UNDERWATER INVESTIGATION
OF THE
DUSABLE PARK DOCKWALL
ALONG THE
MAIN BRANCH OF THE CHICAGO RIVER
IN
CHICAGO, ILLINOIS

APRIL 2005

KUDRNA & ASSOCIATES, LTD.

COLLINS JOB NO. 4372

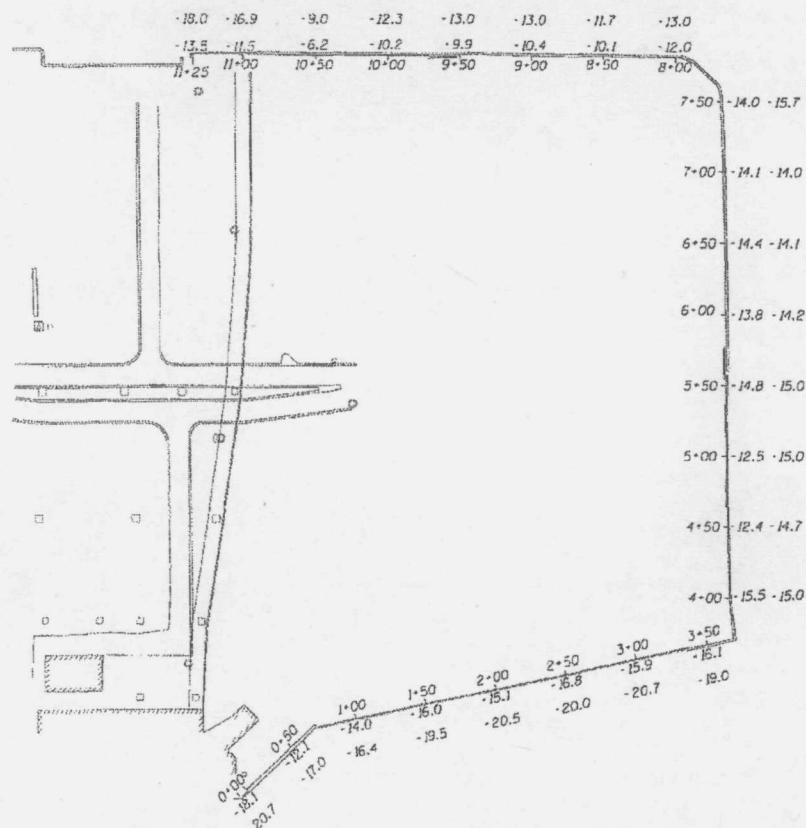
SOUNDING PLAN

1. Approximately 1125 linear feet of the DuSable Park dockwall was inspected under water.
2. At the time of the inspection on April 7, 2005 the waterline was located approximately 7.0 feet below the top of the dockwall at Station 2+00. This corresponds to a waterline elevation of -2.07 feet Chicago City Datum (CCD), based on USGS data taken at Columbus Drive.
3. Soundings indicate the channel bottom depths at the time of inspection and are measured in feet.
4. Soundings were taken parallel to the dockwall, as well as 20 feet from the dockwall.

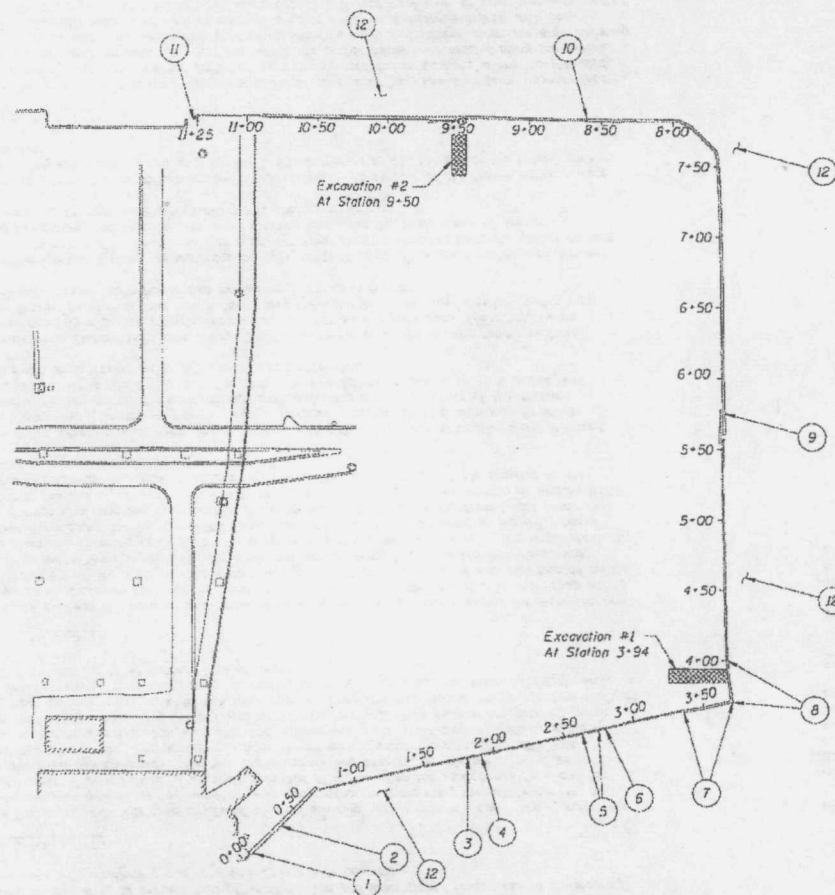
PLAN AND INSPECTION NOTES

- 1 Concrete section loss along east side of expansion joint from the waterline up 2 feet. Area measured 1 foot in width with up to 18 inches of penetration and exposed steel reinforcement having up to 15 percent loss of section.

- 2 Concrete section loss along construction joint from the waterline up 2 feet. Area measured 2 feet in width with up to 8 inches of penetration.
- 3 Area of 100 percent steel section loss measuring 16 inches in height and 8 inches in width at 2 feet above the waterline.

- 4 Heavy impact damage extending downward 6.5 feet from the top of the steel sheeting, with an indentation measuring up to 1 foot deep and a 1 foot long tear in the sheeting.

- 5 Heavy impact damage from 1 foot below the waterline to the top of the steel sheeting, with 1 foot deep indentations. The interlock at Station 2+67 had opened up to 1 inch wide from the waterline to 3 feet below the top of the steel sheeting. Vertical tears in the sheeting extended from 1 foot above the waterline to 4 feet below the waterline, with a 1 foot square area of 100 percent section loss at the waterline.

- 6 Heavy impact damage from the top of the steel sheeting to 1 foot above the waterline. The steel sheeting exhibited 100 percent section loss in this area, with a visible loss of backfill material creating a 3-foot deep sinkhole behind the wall.

- 7 No tie rods visible between Station 3+35 and Station 3+66.
- 8 Heavy impact damage to steel channel whaler at 1.5 feet above the waterline from Station 3+66 to Station 4+00.

- 9 Area of 100 percent steel section loss measuring 2.5 feet high and 2 inches wide, located 3 feet above the waterline.
- 10 Outfall with hole in sheeting measuring 2 feet high by 3 feet wide at 4 feet above the waterline.

- 11 Gap between steel sheeting and concrete dockwall, measuring up to 3 inches wide above the waterline and 18 inches wide below the waterline.
- 12 The Channel bottom material typically consisted of silty sand and random interspersed construction debris, with up to 1.5 feet of probe rod penetration.

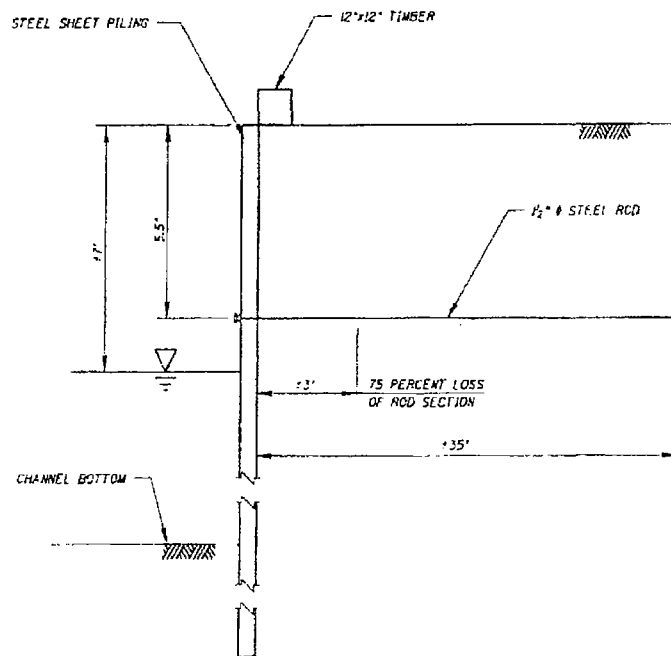
DOCKWALL SECTION AT STATION 3+94

The dockwall anchorage system in this area typically consisted of a 1-1/2 inch diameter steel rod located 5.5 feet below the top of the sheeting. A 3 foot long section of the rod was heavily

corroded adjacent to the steel sheeting, with up to 75 percent loss of section. Further excavation of this area revealed that the rod extended approximately 35 feet from the dockwall. The western end of the rod was free, with no anchorage system observed. In addition, the interior face of the sheet pile wall was heavily corroded, with up to 20 percent loss of section. Refer to Figure 5 in Appendix A for a section view of the dockwall at Station 3+94. Refer to Photographs 19 through 21 in Appendix B for views of the excavation area.

While excavating this area, the northern end of the dockwall anchorage system was observed from Station 3+35 to Station 3+60. The anchorage system consisted of 1-1/2 inch diameter steel rods extending approximately 28 feet from the dockwall. The rods were anchored to timber railroad ties, measuring 12 inches by 12 inches. No additional wall anchorage components, such as sheeting or soldier piles, were observed. It should be noted that no ties extended through the dockwall in this area.

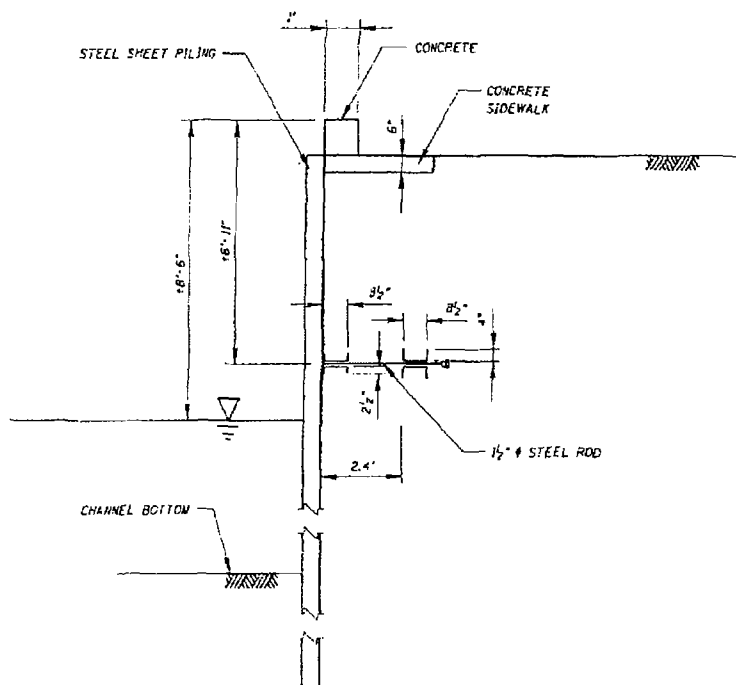
DOCKWALL SECTION AT STATION 9+50

The dockwall anchorage system in this area typically consisted of a 1-1/2 inch diameter steel rod located approximately 7 feet below the top of the sheeting. Light corrosion of the anchor was evident, with less than 10 percent loss of section. The rod extended approximately 3 feet behind the steel sheeting, where it was attached to two channels. However, no additional wall anchorage components were observed in this area. In addition, moderate oxidation of the interior face of the sheet pile wall was observed, having less than 10 percent loss of section. Refer to Figure 6 in Appendix A for a section view of the dockwall at Station 9+50. Refer to Photographs 22 and 23 in Appendix B for views of the excavation area.

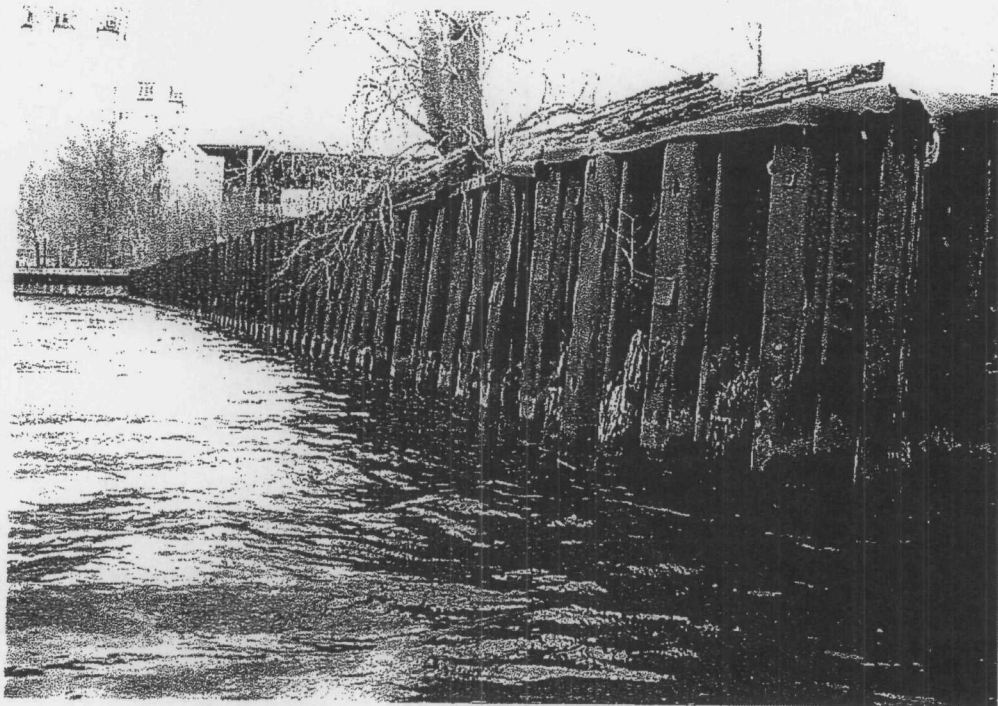
Photograph 1. Overall View of South Dockwall Face, Looking Northwest from Station 3+66.

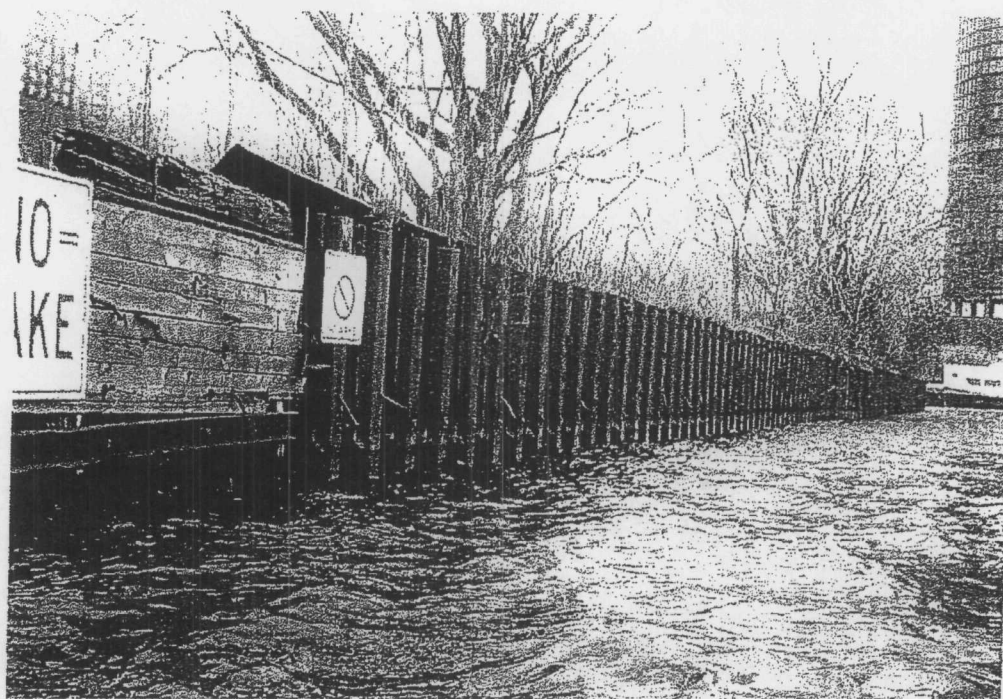
Photograph 2. Overall View of East Dockwall Face, Looking Northwest from Station 3+66.

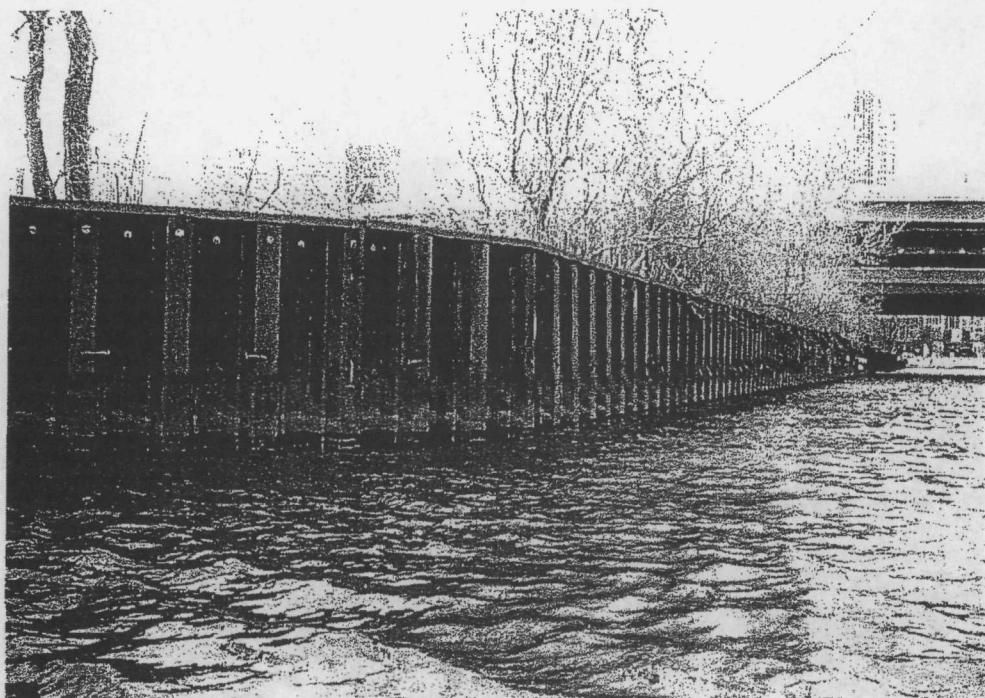
Photograph 3. Overall View of North Dockwall Face, Looking Southwest from Station 7+77.

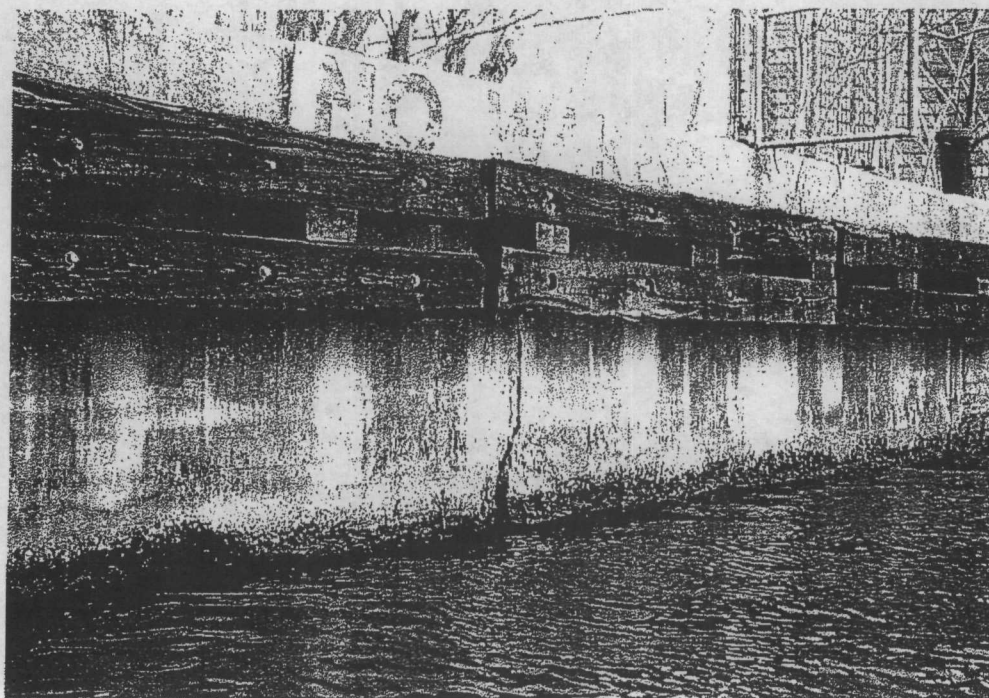
The dockwall in this area consisted of timber Wakefield sheeting with a concrete cap. Timber piles, measuring approximately 12 inches in diameter, were located approximately 1 foot in front of the timber sheeting. The outer layer of timber sheeting was in satisfactory condition with 1/8-inch awl penetrations and random 2-inch wide gaps between sheets. Interior timber piles filled in the gaps at all observed locations. Above water, the concrete cap was typically in fair condition with heavy concrete scale along the bottom corner, having up to 4 inches of penetration. This scale extended 18 inches along the vertical cap face and 12 inches along the cap underside. Random reinforcement was observed in this area, having up to 15 percent loss of section. The protective timber fender was in satisfactory condition with light weathering and random 1/2-inch wide checking. Below water, there was a 1-inch thick layer of marine and aquatic growth extending from the waterline to the channel bottom. Refer to Photographs 4 and 5 in Appendix B for views of the dockwall in this area.

Photograph 4. Dockwall at Station 0+30, Looking Northeast.

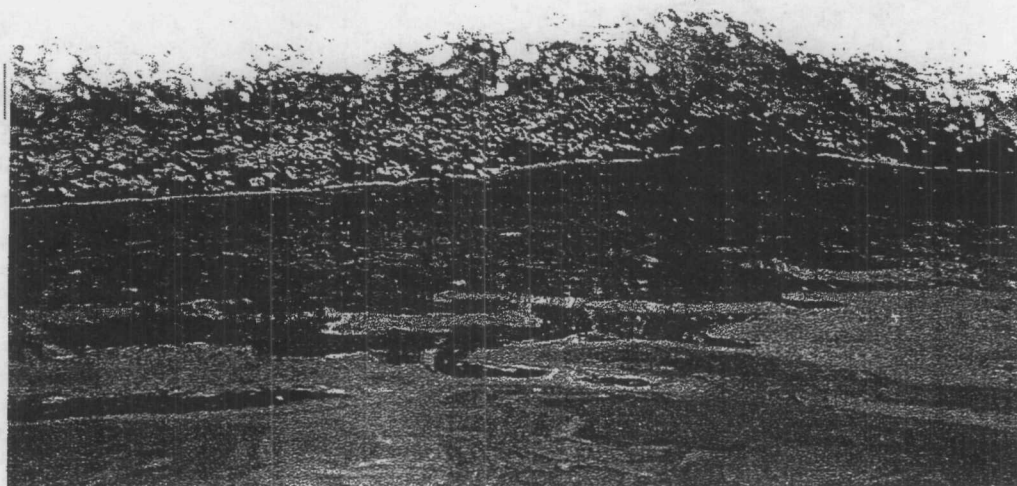
Photograph 5. View of Typical Concrete Cap Condition along Waterline at Station 0+20, Looking North.

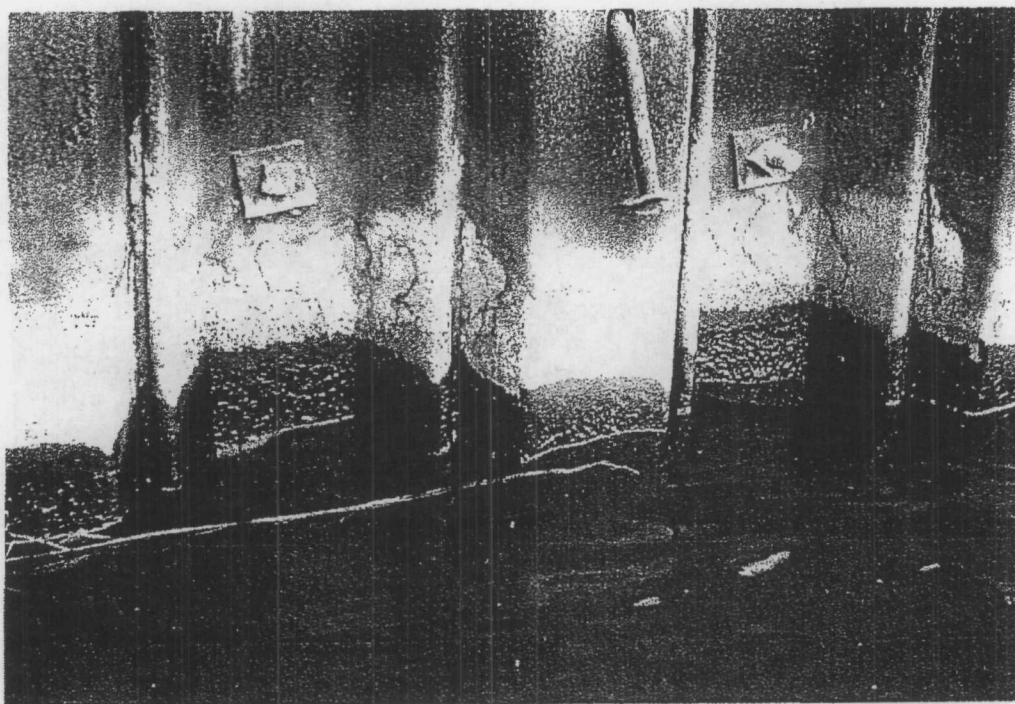
The dockwall in this area was constructed of steel sheeting. Below water, the steel sheeting typically exhibited random rust nodules measuring up to 1 inch in diameter and 1/32-inch deep pitting over 25 percent of the steel surface area. A 1/16-inch thick layer of scale was also located on the sheeting surfaces below water. Heavier scale and pitting, measuring up to 1/8 inch deep, was located from the waterline down 2 feet with up to 10 percent loss of section. The timber fenders were typically missing and the remaining fender anchors were either deformed or missing. Heavy impact damage was observed from Station 2+63 to Station 2+80, extending from 1 foot below the waterline to the top of the wall. All interlocks were intact, except for one location at Station 2+67. This interlock had up to 1 inch of separation from 3 feet below the top of the sheeting to the waterline. In addition, a 1-inch thick layer of marine and aquatic growth extended from the waterline to the channel bottom. Refer to Photographs 6 through 10 in Appendix B for views of the dockwall in this area.

Photograph 6. View of Typical Steel Condition along Waterline at Station 0+75, Looking North.

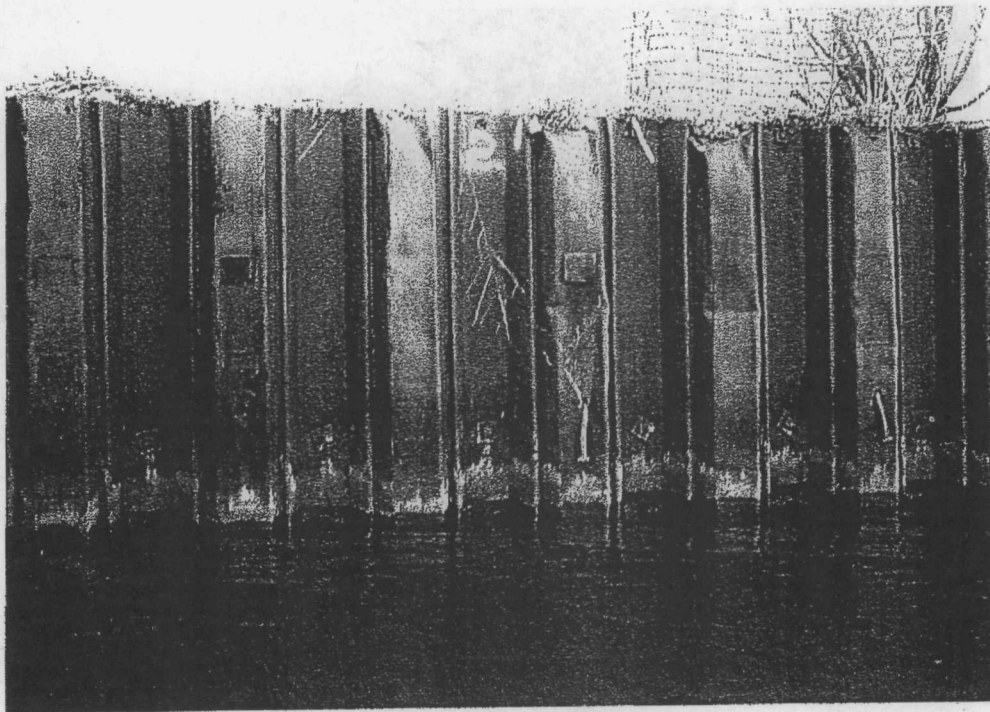
Photograph 7. View of Dockwall at Station 2+00, Looking North.

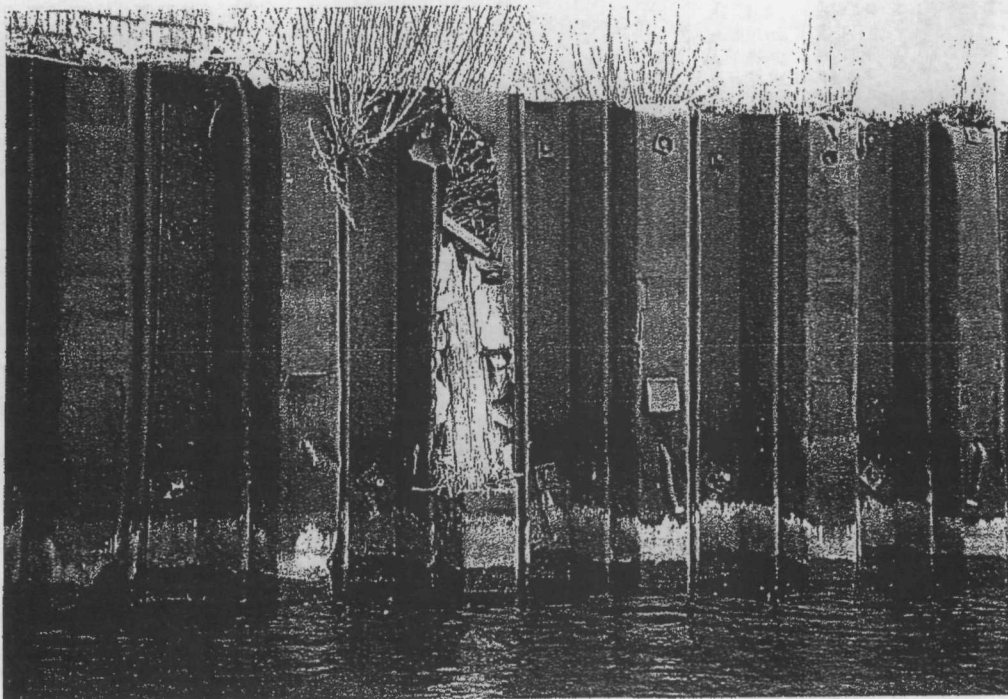
Photograph 8. View of Failed Sheet at Station 2+80, Looking North.

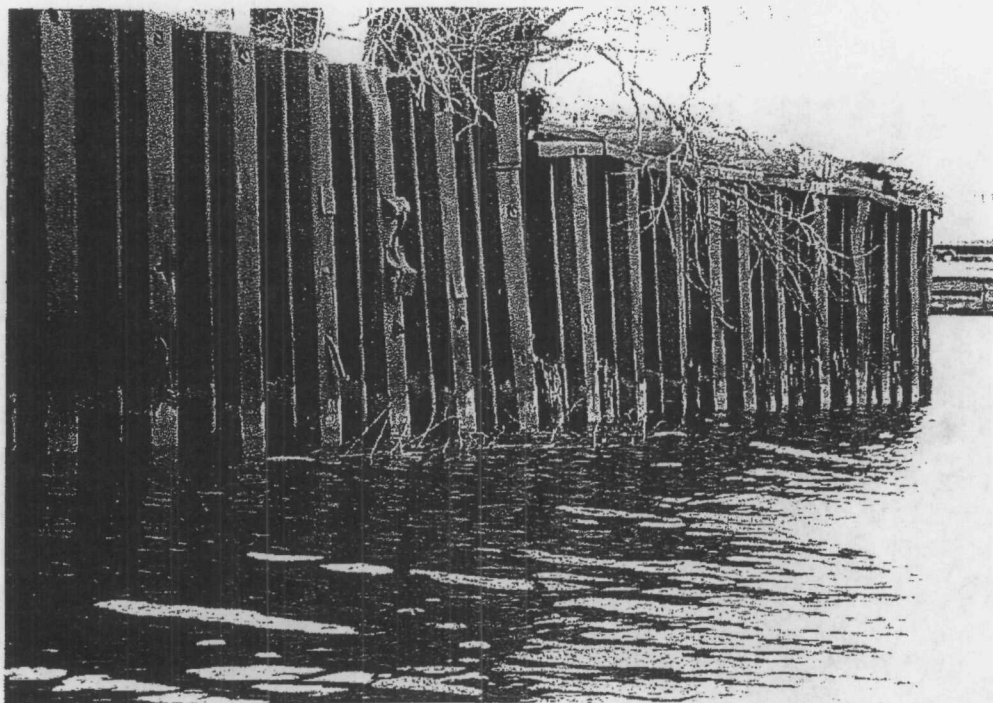
Photograph 9. View of Typical Dockwall Configuration, Looking Northeast from Station 3+00.

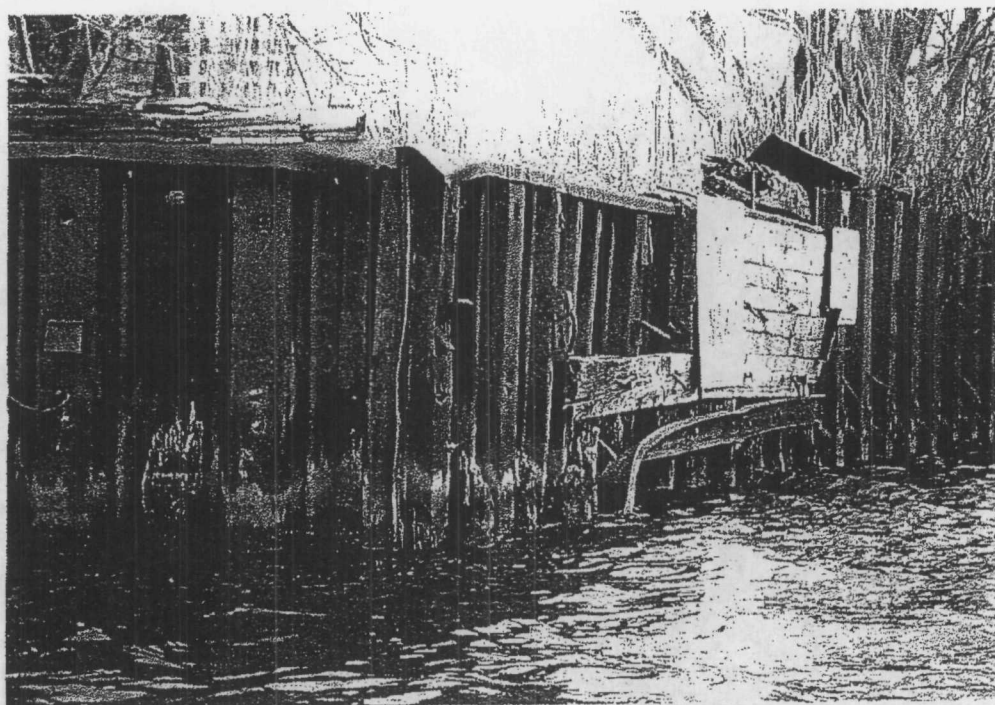
Photograph 10. View of Typical Steel Condition, Looking Northwest from Station 3+66.

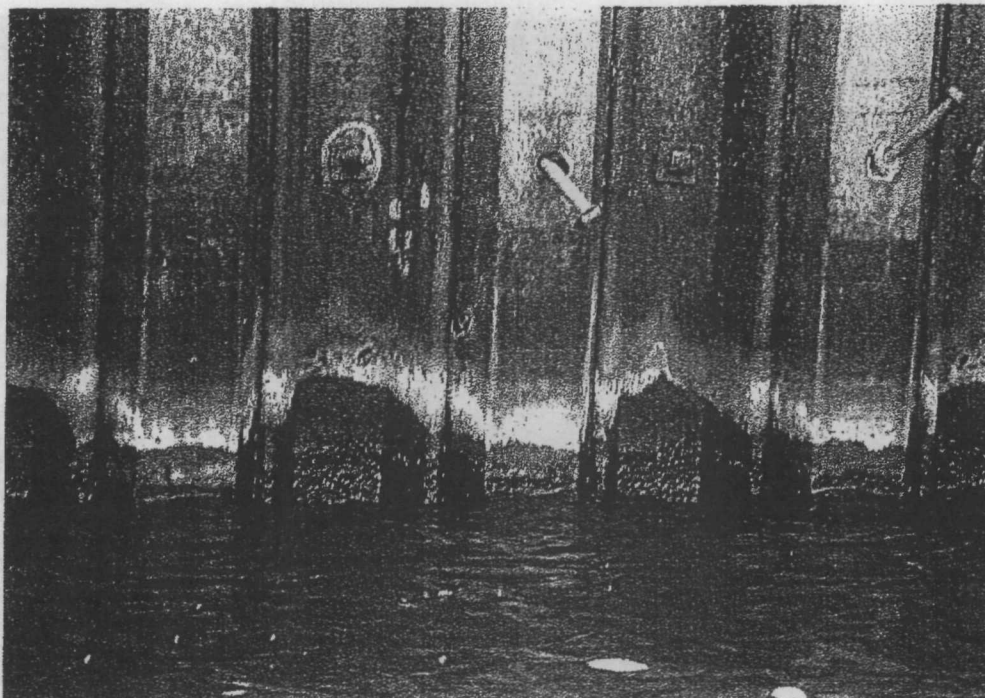
The dockwall in this area consisted of steel sheeting. The steel plate washers located on every other outer pan face had failed or were heavily corroded in locations where the threaded anchor rod extended outward. At locations where the anchor heads were located along the exterior wall face, the washers typically exhibited light to moderate corrosion. Below water, the steel sheeting typically exhibited random rust nodules measuring up to 1 inch in diameter and 1/32-inch deep pitting over 25 percent of the steel surface area. A 1/16-inch thick layer of scale was also located on the sheeting surfaces below water. Heavier scale and pitting, measuring up to 1/8-inch deep, was located from the waterline down 2 feet with up to 10 percent loss of section. The timber fenders were typically missing and the remaining fender anchors were either deformed or missing. All interlocks were intact, with a 1 inch thick layer of marine and aquatic growth extending from the waterline to the channel bottom. Refer to Photograph 11 in Appendix B for a view of the dockwall in this area.

Photograph 11. View of Typical Steel Condition at Station 7+00, Looking West.

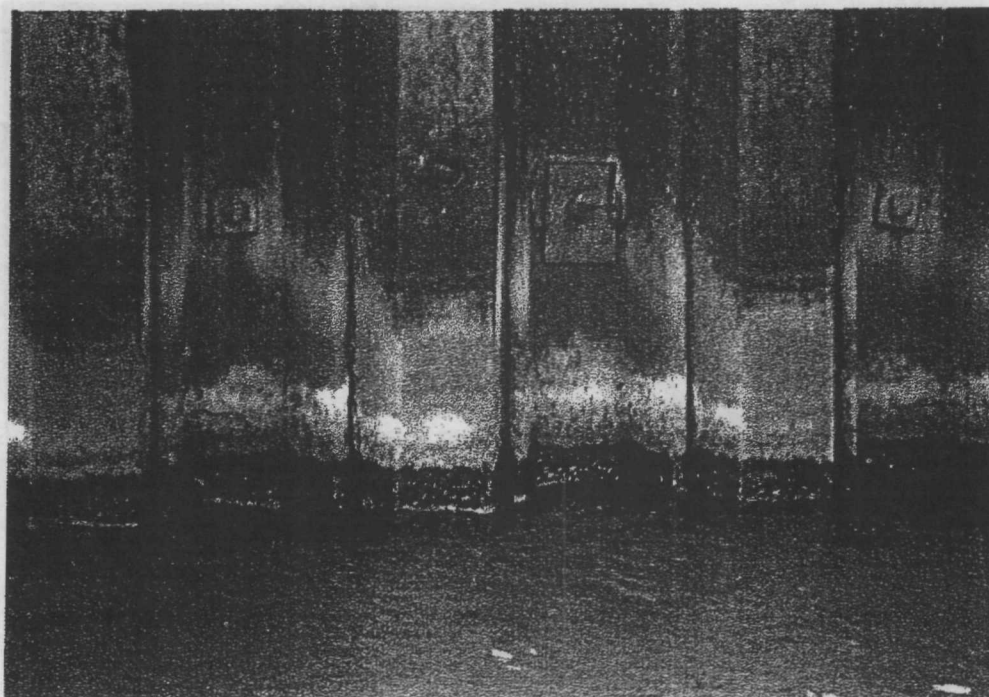
The dockwall in this area was constructed of steel sheeting. Along this portion of the wall, heavy pack rust was observed between the plate washers and sheeting. Below water, the steel sheeting typically exhibited random rust nodules measuring up to 1 inch in diameter and 1/16-inch deep pitting over 25 percent of the steel surface area and at the interlocks. Heavier scale and pitting, measuring up to 1/8 inch deep, was located from the waterline down 2 feet with up to 10 percent loss of section. The timber fenders were typically missing and the remaining fender anchors were either deformed or missing. All interlocks were intact, with a 1-inch thick layer of marine and aquatic growth extending from the waterline to the channel bottom. Refer to Photograph 12 for a view of the dockwall in this area.

Photograph 12. View of Typical Steel Condition at Station 8+00, Looking West.

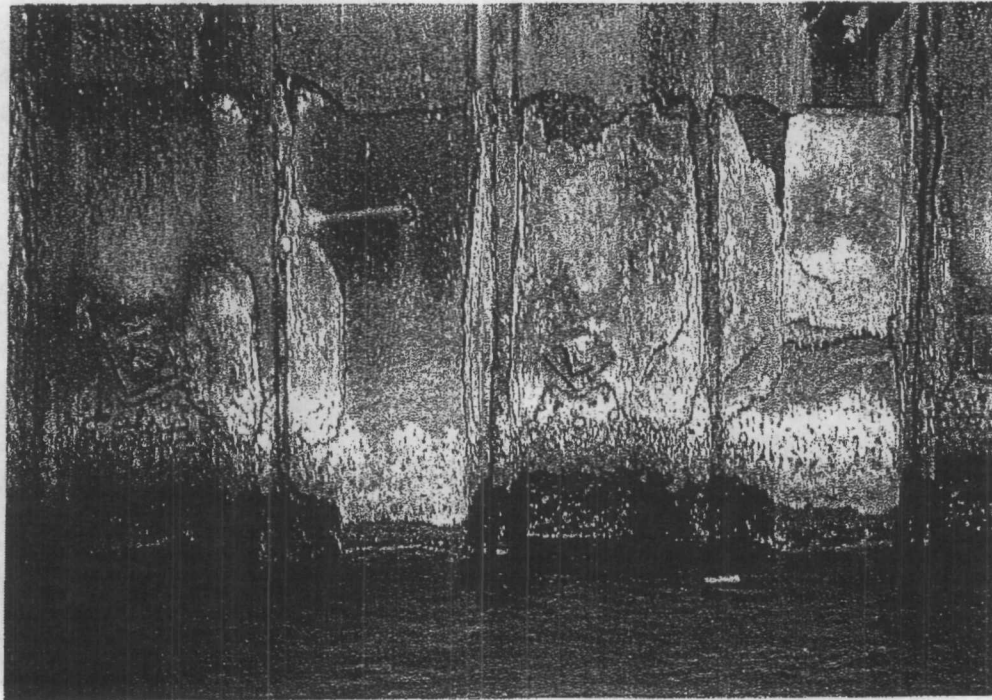
The dockwall in this area consisted of steel sheeting. Along this portion of the wall, the anchor rod nuts typically exhibited up to 25 percent section loss, with random nuts exhibiting up to 75 percent loss of section. Below water, the steel sheeting typically exhibited random rust nodules measuring up to 1 inch in diameter and 1/16-inch deep pitting. Heavy pitting, measuring up to 1/8-inch deep, extended down 5 feet from the waterline. Above water, the sheeting typically exhibited heavy section loss from the waterline up 3 feet with 50 percent loss of section. The heaviest section loss was located at 3 feet above the waterline, where there was up to 100 percent loss of section. The timber fenders were typically missing and the remaining fender anchors were either deformed or missing. All interlocks were intact, with a 1-inch thick layer of marine and aquatic growth extending from the waterline to the channel bottom. Refer to Photographs 13 through 17 in Appendix B for views of the dockwall in this area.

Photograph 13. View of Typical Steel Condition at Station 9+40, Looking South. Note Heavy Layer of Pack Rust and Steel Section Loss from the Waterline up 2 Feet.

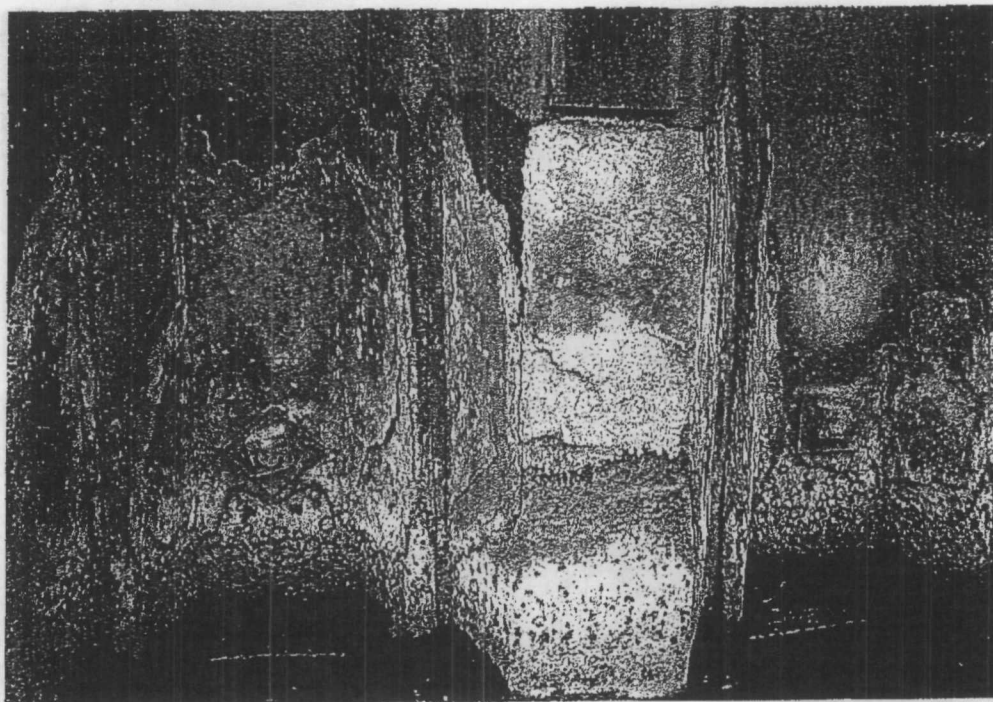
Photograph 14. View of Typical Steel Condition at Station 9+40, Looking South. Note Heavy Layer of Pack Rust and Steel Section Loss from the Waterline up 2 Feet.

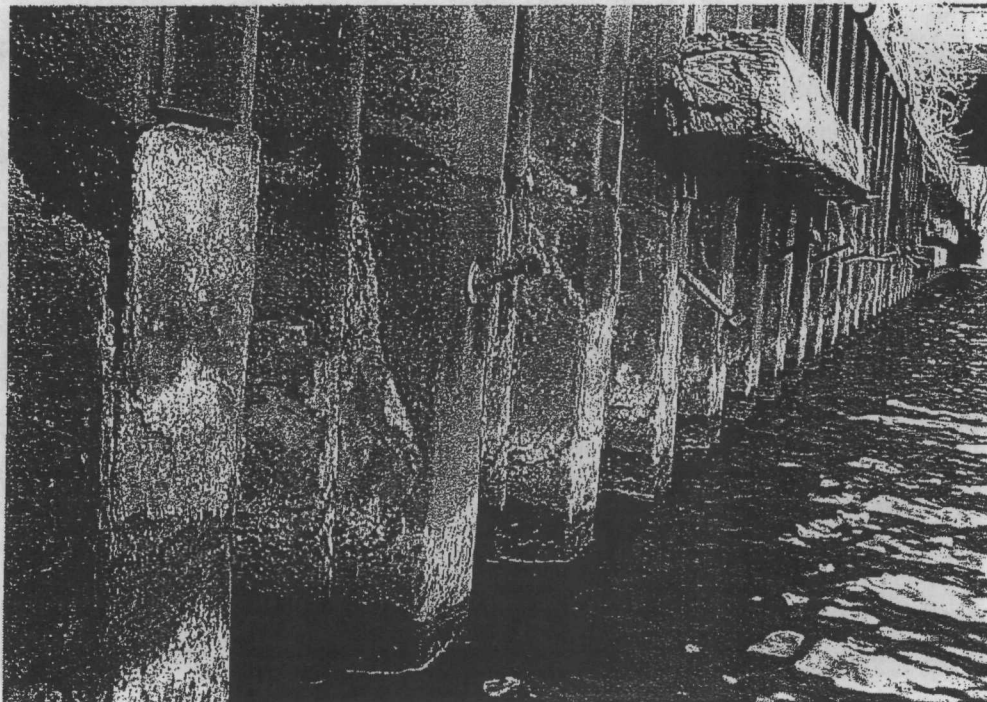
Photograph 15. View of Typical Steel Condition, Looking Southwest from Station 9+40.

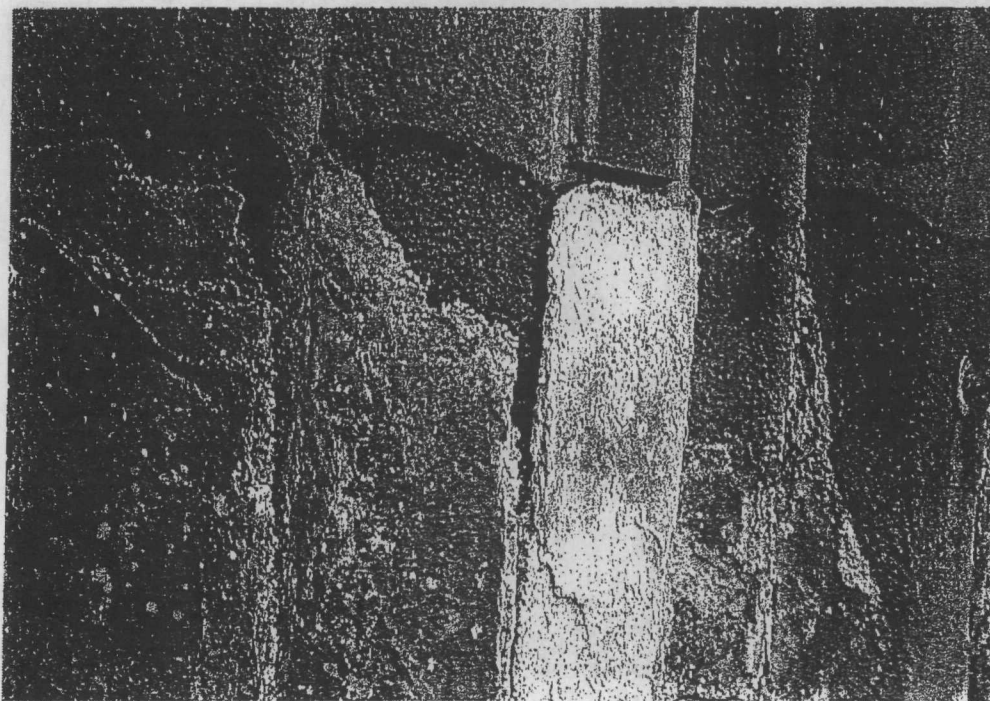
Photograph 16. View of Typical Steel Condition, Looking Southwest from Station 9+40. Note Heavy Steel Section Loss 2 Feet Above the Waterline.

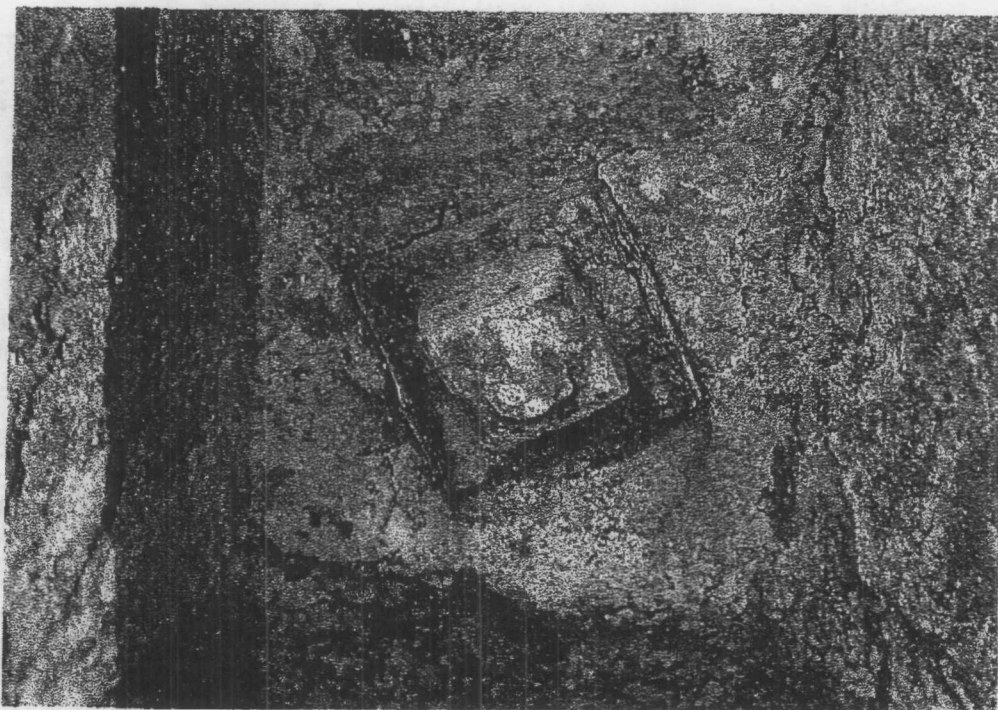
Photograph 17. View of Typical anchor Condition at Station 9+80, Looking South.

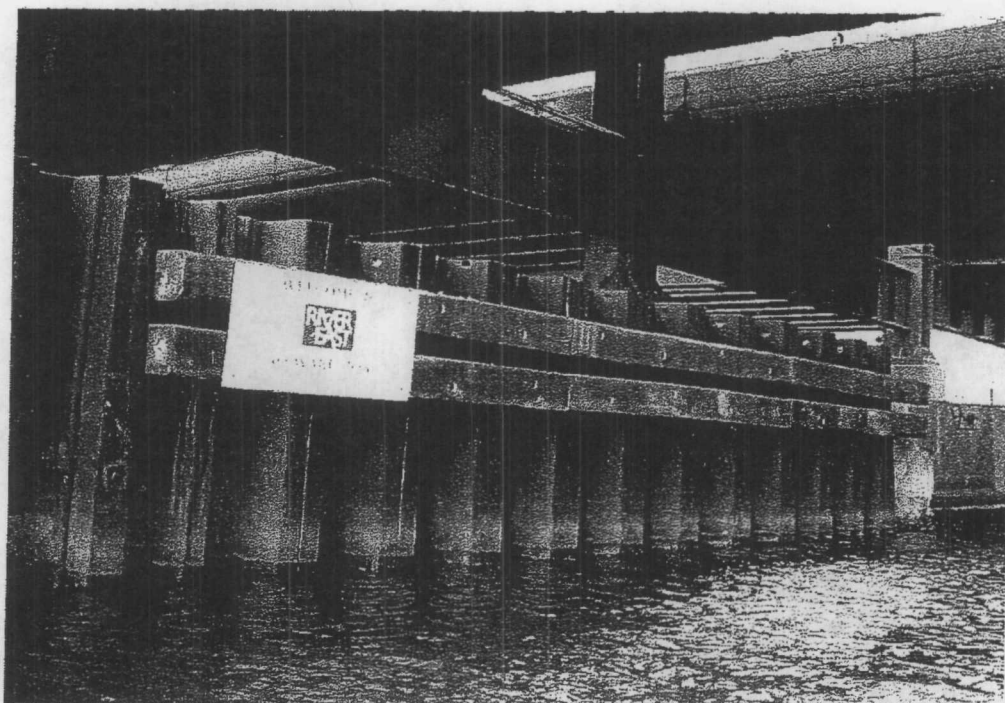
The dockwall in this area was constructed of steel sheeting. Below water, the steel sheeting typically exhibited random rust nodules measuring up to 1 inch in diameter and 1/32-inch deep pitting over 25 percent of the steel surface area. A 1/16-inch thick layer of scale was also located on the sheeting surfaces below water. Heavier scale and pitting, measuring up to 1/8-inch deep, was located from the waterline down 2 feet with up to 10 percent loss of section. Above water, the anchor washers typically exhibited up to 10 percent section loss. All interlocks were intact, with a 1-inch thick layer of marine and aquatic growth extending from the waterline to the channel bottom. Refer to Photograph 18 for a view of the dockwall in this area.

Photograph 18. View of Typical Dockwall Configuration, Looking Southwest from Station 10+85.

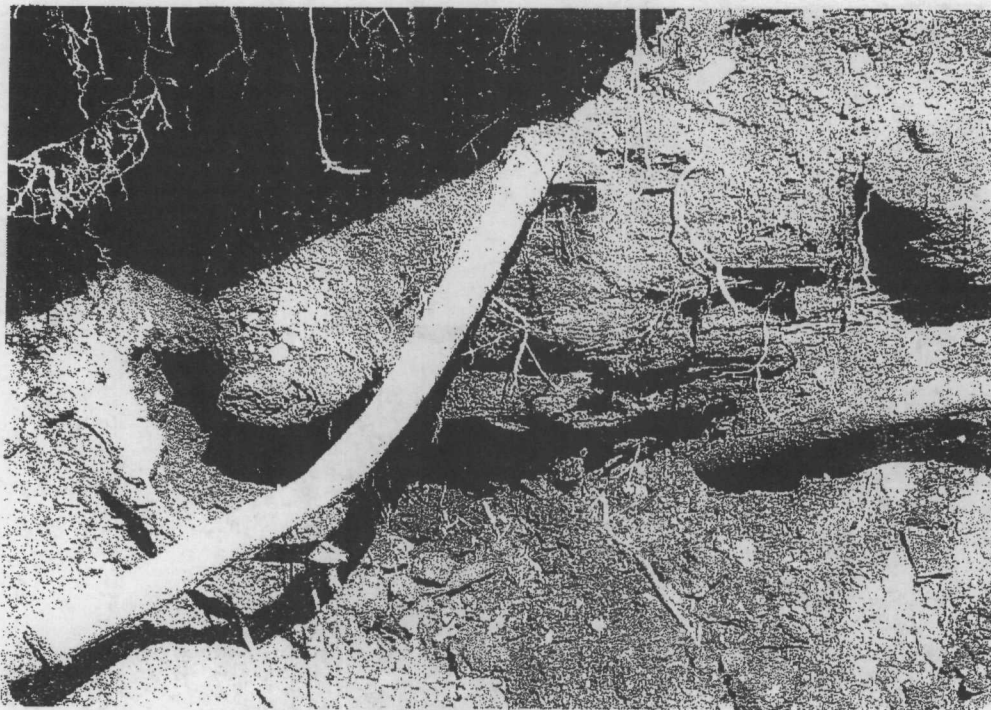
Photograph 21. View of Western Anchor Rod End at Station 3+94. Note Lack of Anchor Restraint System.

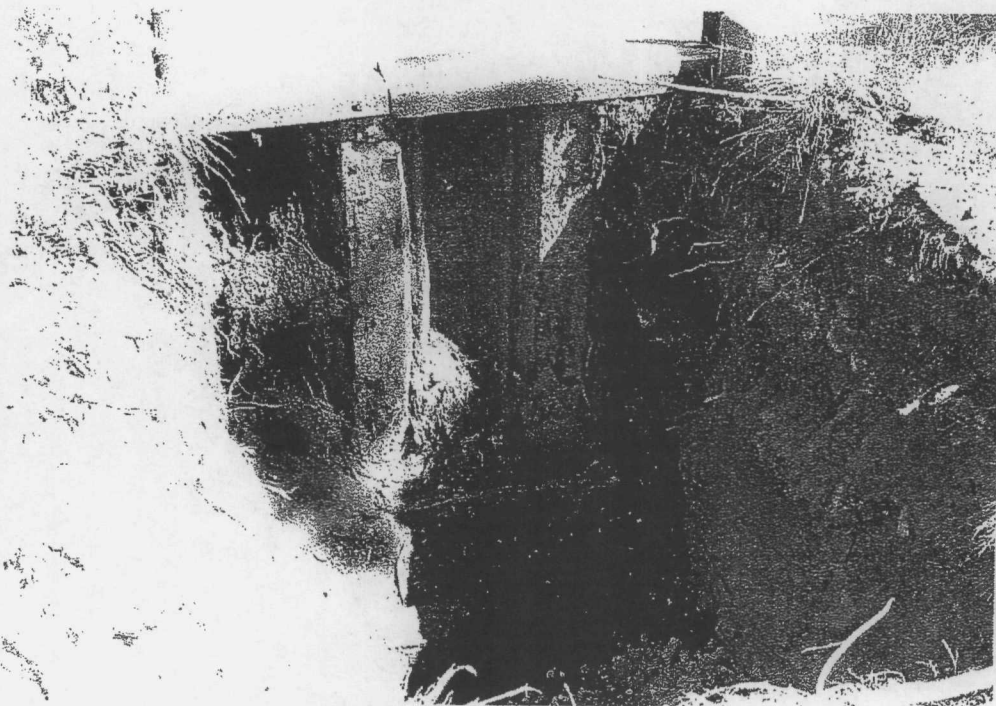
Photograph 22. View of Interior Steel Sheet Pile Face at Station 9+50.

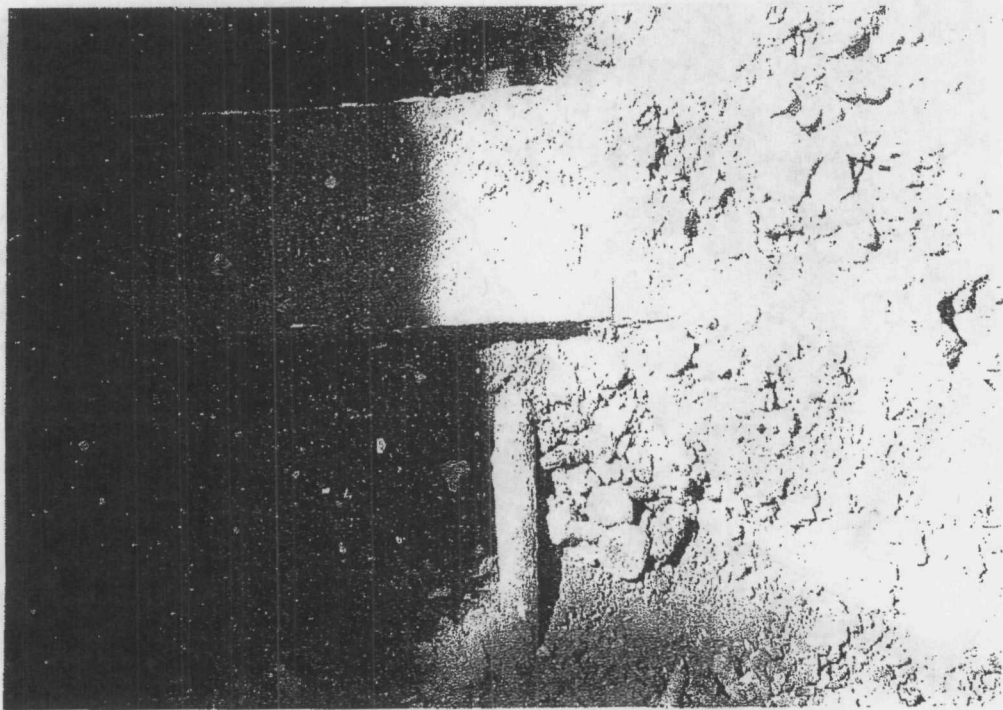
Photograph 23. View of Anchor Rod to Channel Connection at Station 9+50.
